## Clinical Case \_ Posterior Restoration

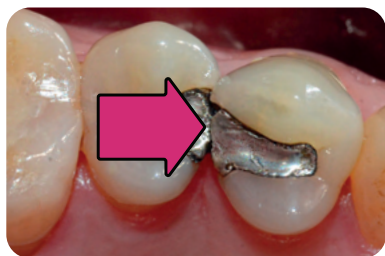
[Figure. 1] Before treatment
